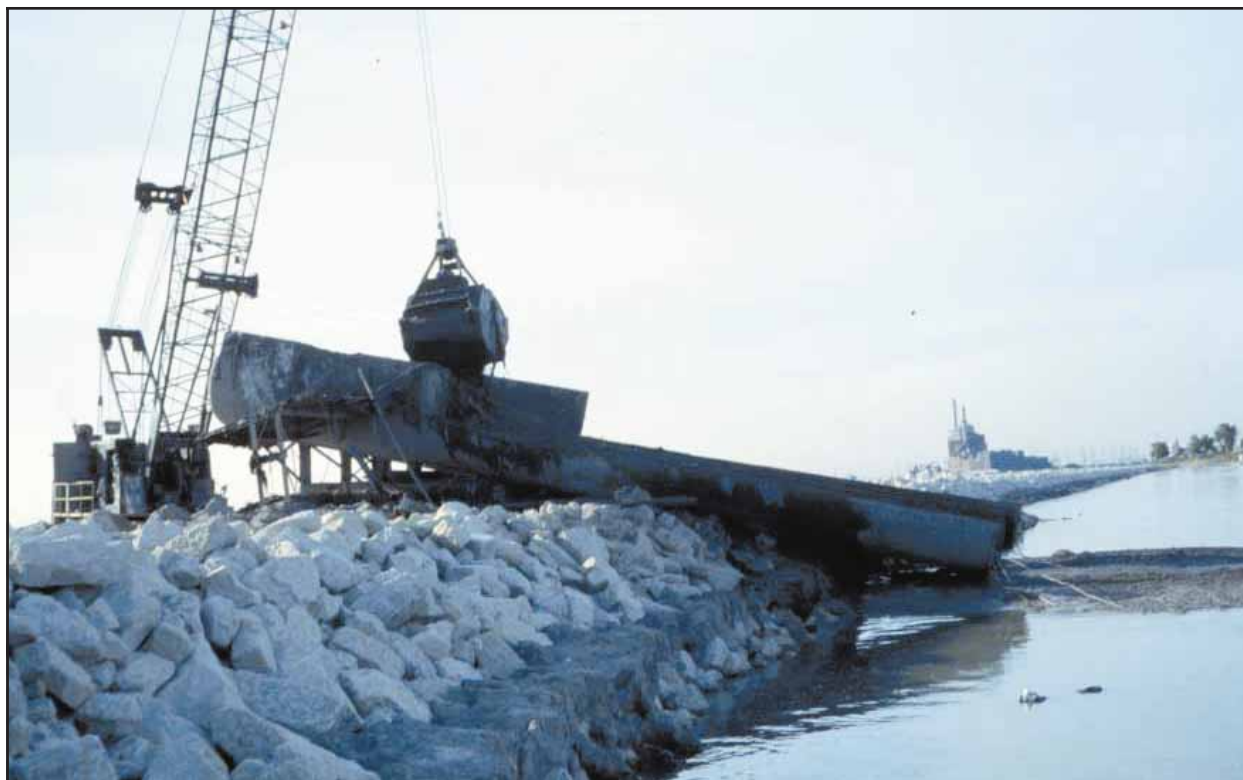
Figure 7. Chicago CDF showing placemnt of fine-grained dredged material blanket on inside dike face (photo courtesy Chicago District)
